Survey of trees for the Parish Council located at Aldbrough St John

Prepared by Denis Gregson,
Arboricultural Officer, on behalf of
North Yorkshire County Council

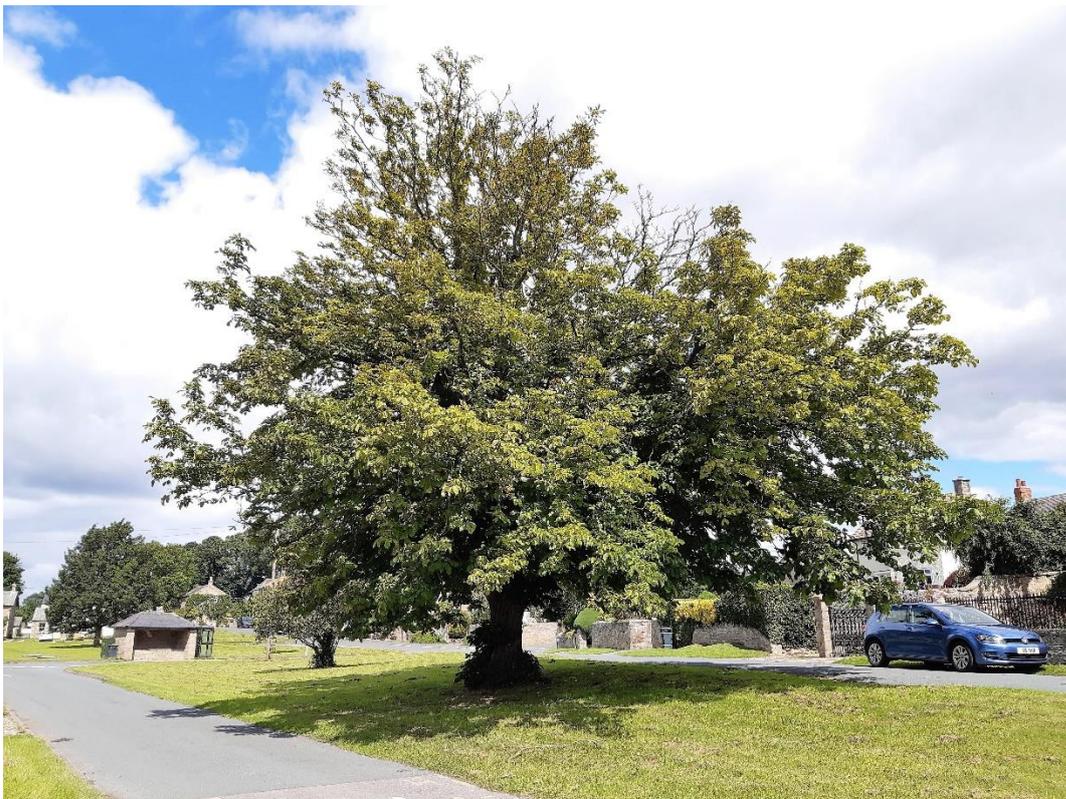
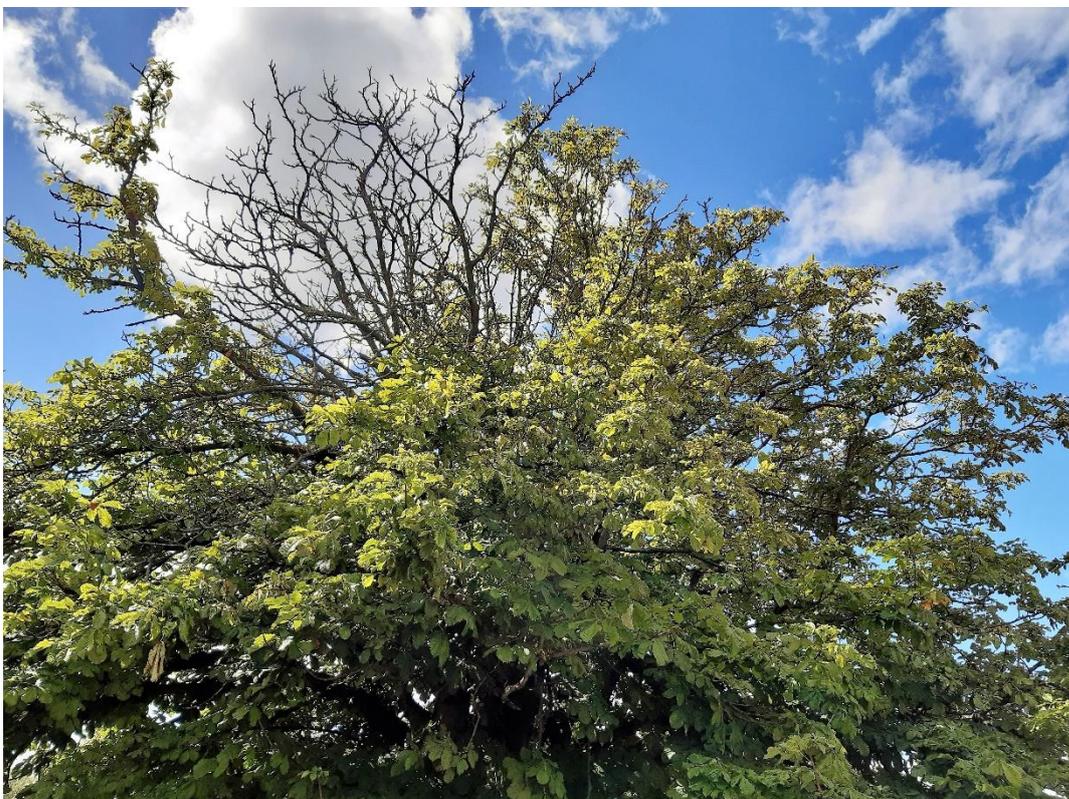
Tree Number	Species	Age	Condition	Dbh	Height	Comments	Recommendations	Priority
0DK0	Plum	Mature	Reasonable	7.5-15cms	0-5m	Sprawling multi-stemmed tree of modest stature.	No work required	n/a
0DK1	Horse Chestnut	Mature	Poor	60-90cms	10-15m	Very badly affected by bleeding canker with extensive part-crown dieback evident and previous limb loss visible. The tree is in rapid decline and further limb loss is likely.	Dismantle to ground level and grind stump.	Medium
0DK2	Sycamore	Semi-Mature	Good	30-60cms	5-10m	Twin-stemmed tree located adjacent to Greencroft, narrow fork with included bark.	No work required	n/a
0DK3	Downy Birch	Mature	Good	15-30cms	5-10m	Located adjacent to Greencroft, cavity at 1m minor deadwood in canopy.	No work required	n/a
0DK4	Himalayan Birch	Semi-Mature	Reasonable	15-30cms	5-10m	Located adjacent to Greencroft, narrow forks, minor deadwood and small, sparse foliage evident.	No works required	n/a

1. Several mature Horse Chestnuts within the survey area are affected by Horse Chestnut bleeding canker a condition that has widely varying effects on the host tree, in particular tree number 0DK1 is in such a condition that removal is recommended.

Tree number ODK1 (Horse Chestnut) showing extent of dieback and declining condition due to extensive effects of bleeding canker. The tree has suffered multiple previous branch failures.

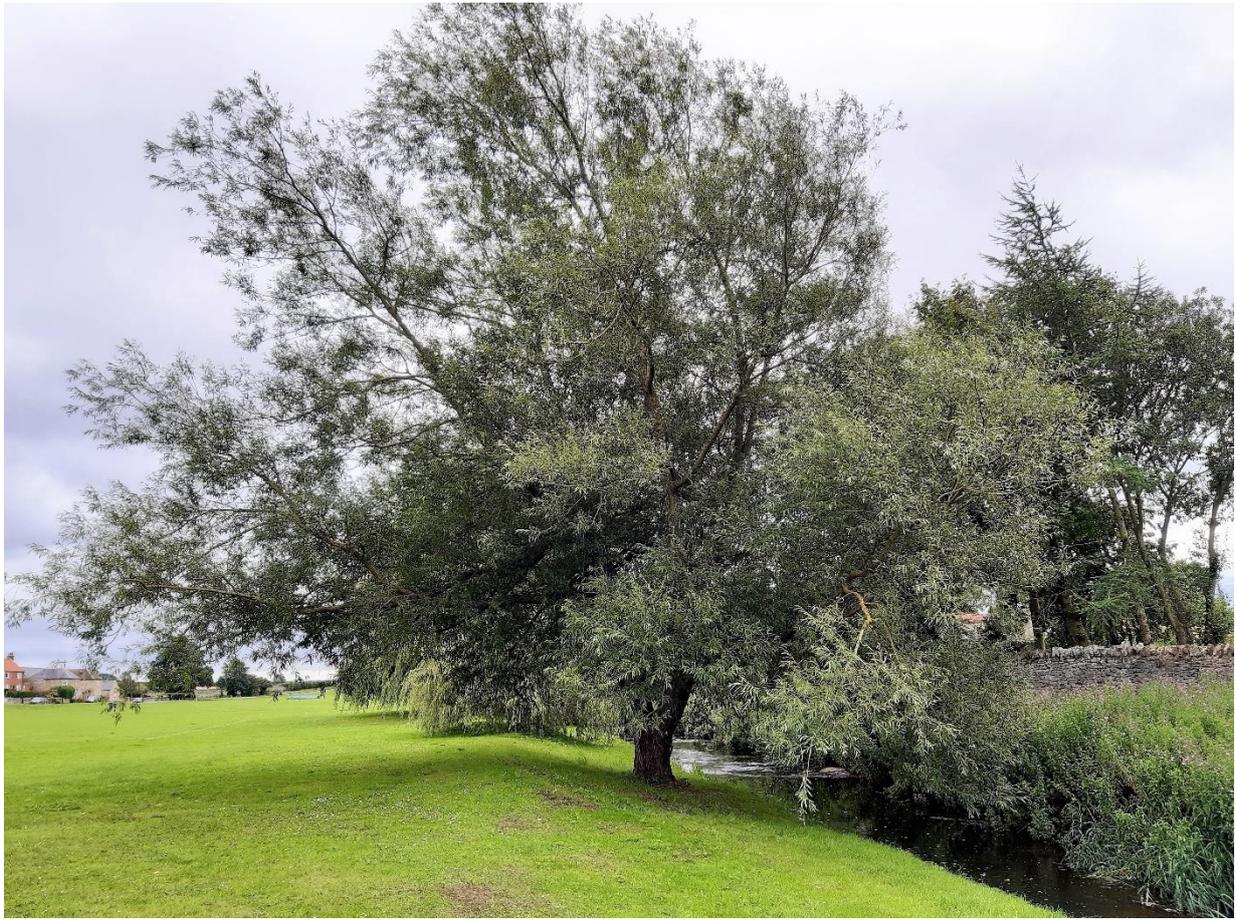
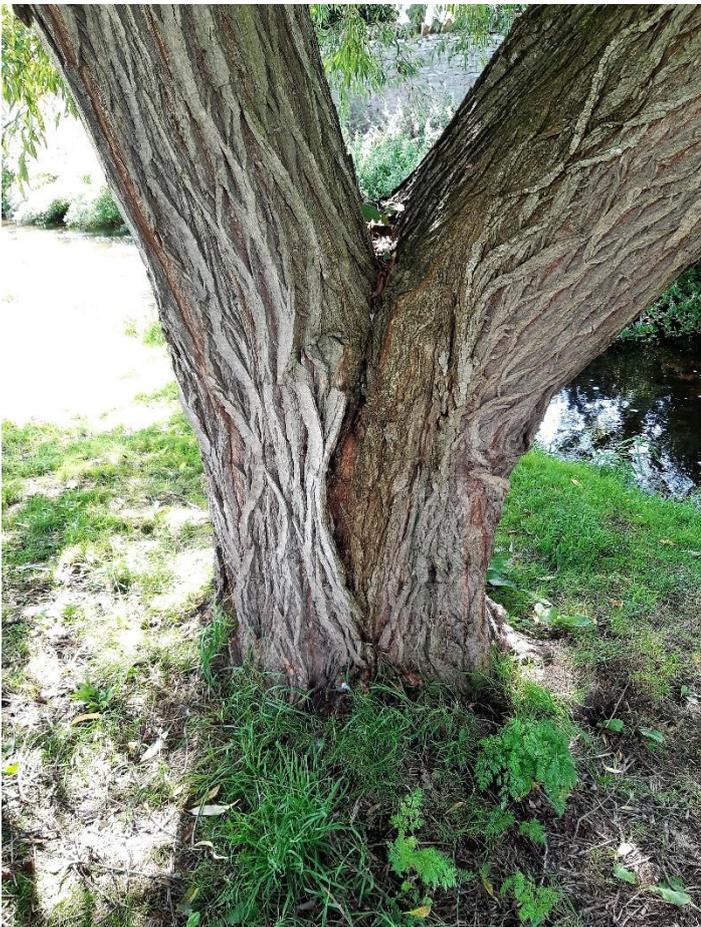
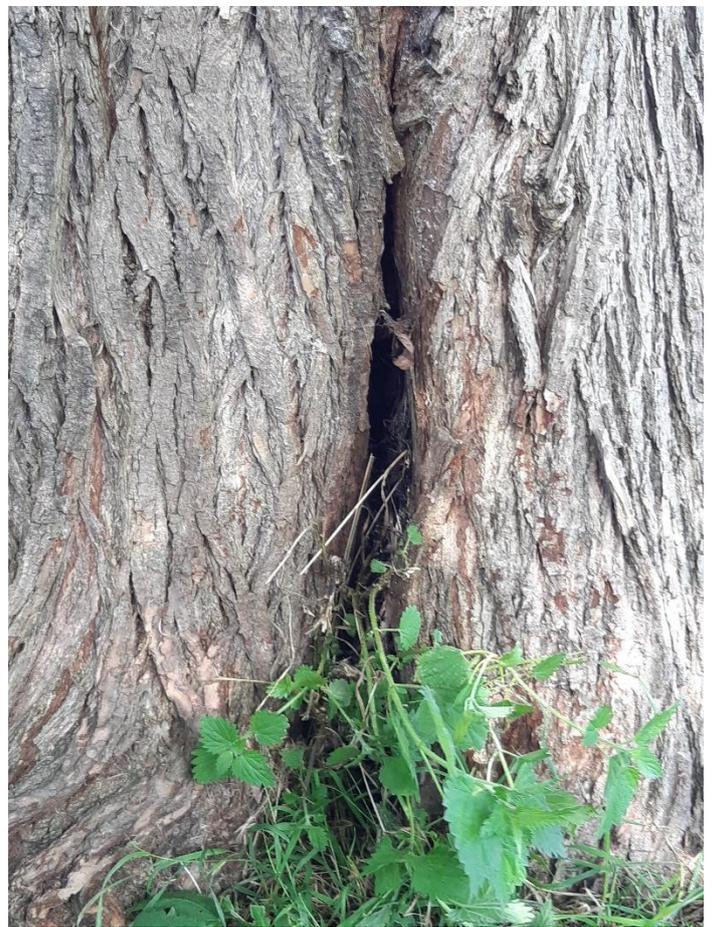
0DLB	Lawson Cypress	Semi-Mature	Good	30-60cms	5-10m	Located to the rear of Bridge House	No work required	n/a
0DLC	Crack Willow	Mature	Good	60-90cms	10-15m	Very large prominent tree located on Low Green next to beck. Wide, spreading canopy with low branches and evidence of previous limb loss. Structural crack has developed in the bole in combination with a basal cavity which is likely to result in failure if the canopy is allowed to developed unchecked.	Pollard at 3-4m to remove mechanical stresses imposed on structurally compromised bole	Medium
0DLD	Weeping Willow	Mature	Reasonable	60-90cms	0-5m	Multi-stemmed regrowth from old stump.	No work required	n/a
0DLE	Weeping Willow	Mature	Reasonable	>90cms	15-20m	Very large, prominent tree with significant visual amenity. The tree has suffered previous limb loss due to canopy weight and structurally weak branch attachments, there is currently an obvious 'outgrowth' of a major limb in the lower canopy which extends beyond the normal canopy line.	Carry out selective branch removal and weight reduction in order to lessen mechanical loading of limbs.	Medium

Tree number 0DLC (Willow) showing whole canopy (top) and details of structural crack in bole and associated basal cavity (below)

5. Willows – there are some large willows of different species within the survey area which form an important contribution to the amenity of the village setting however some have attained the stature where branch failure becomes more frequent due to increased weight and mechanical stresses (particularly in high wind events) therefore a balance needs to be struck to enable the trees to be retained whilst considering foreseeable failures, in some cases it may be appropriate to pollard or coppice such trees to remove/reduce hazards and instigate new canopy growth which may be managed at a reduced size. This treatment has an obvious initial impact upon the visual aspect of the tree. In other cases, a more 'selective' approach to remove branches or parts of branches may be more appropriate.

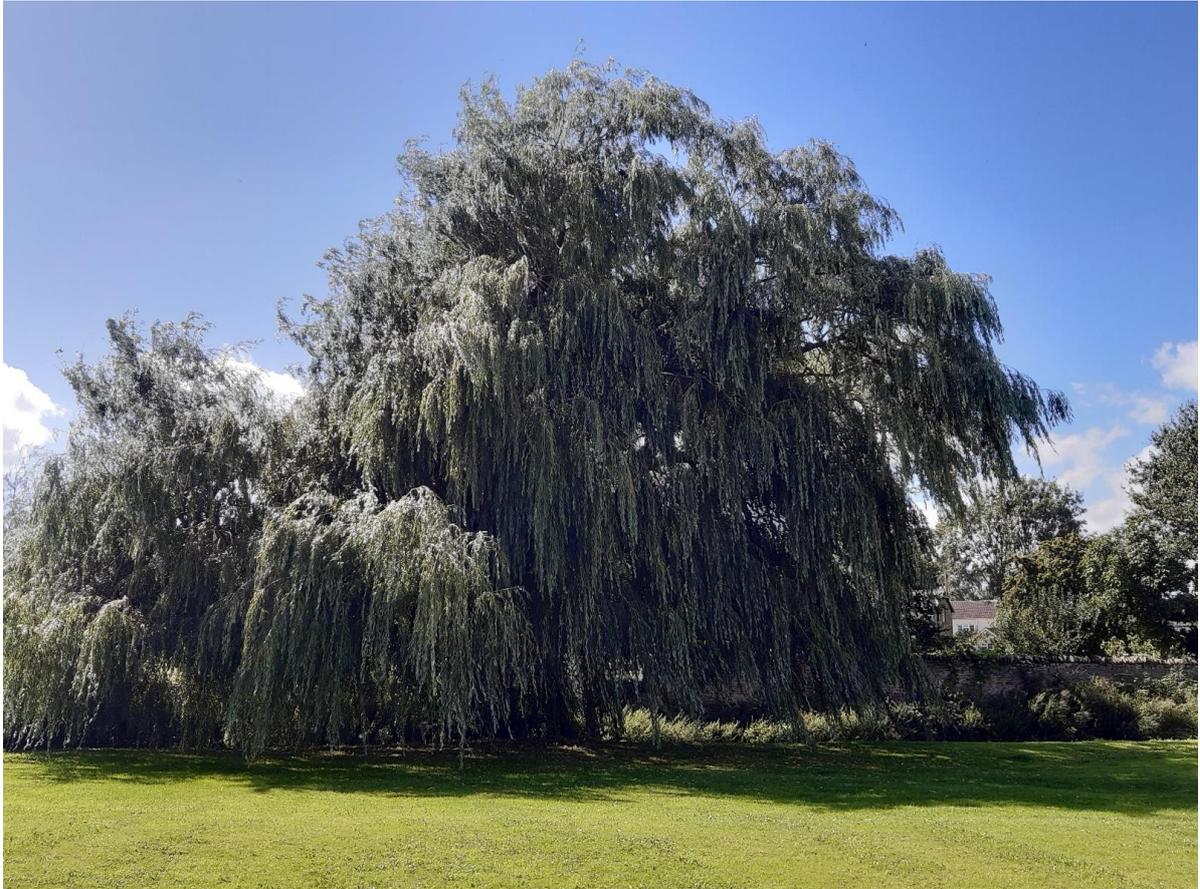
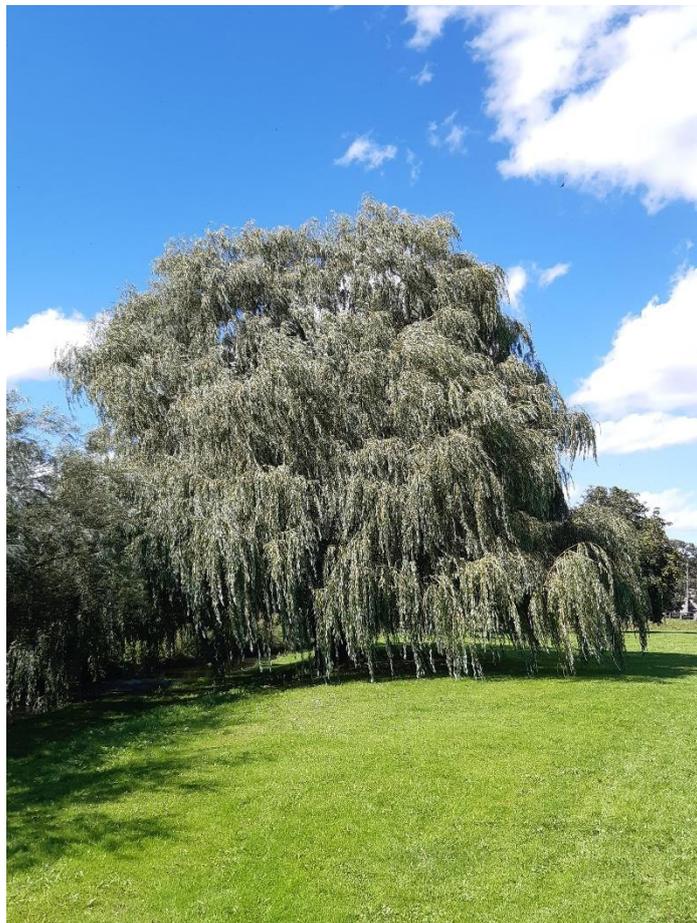
Tree number ODLE (Weeping Willow) showing large spreading canopy with obvious 'outgrowth' of the lower canopy

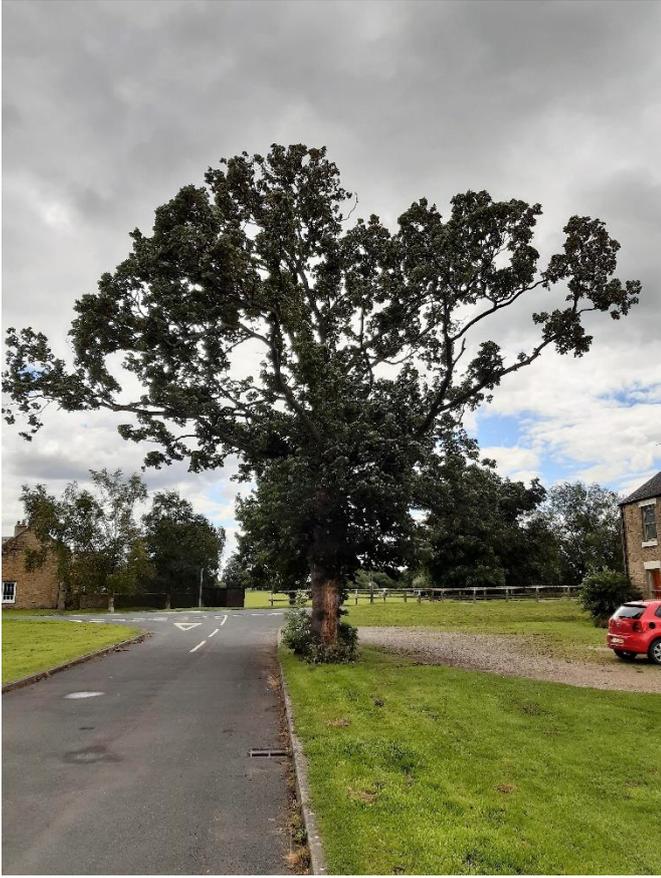
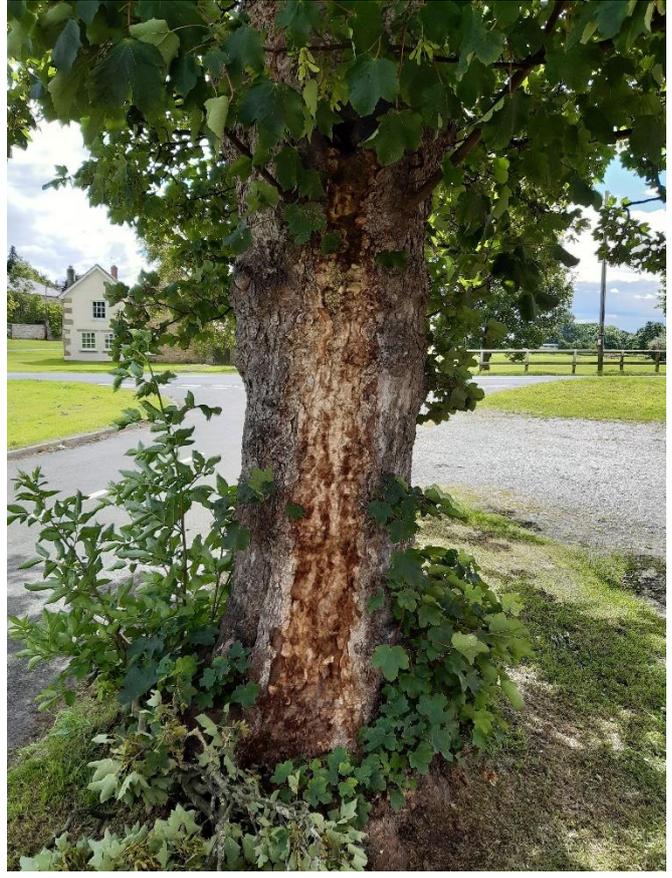
0DJT	Wych Elm	Semi-Mature	Good	7.5-15cms	10-15m	No major defects identified, growing close to fabric of bridge.	No work required	n/a
0DJU	Sycamore	Mature	Poor	30-60cms	10-15m	Located outside Sycamore Cottages, declining condition evident in sparse canopy condition, extensive past pruning has led to numerous stem cavities which have coalesced resulting in a column of decay developing in the trunk of the tree. A strip of weeping exudate is evident on the north side of the bole.	<p>Option 1 – Pollard the tree to reduce structural issues and attempt to instigate regrowth of smaller canopy.</p> <p>Option 2 – Dismantle to ground level and grind stump.</p> <p>See additional notes section in main body of report for further discussion</p>	Medium
0DJW	Norway Maple	Mature	Good	60-90cms	10-15m	Located on High Green, cables running through canopy.	Prune to clear cables by 1m	Low
0DJX	Sycamore	Mature	Good	30-60cms	10-15m	Located on High Green in front of Stanwick Arms, no major defects identified.	No work required	n/a

Tree number 0DJU (Sycamore) showing canopy decline and close up detail of exudate strip on north side of stem

3. Tree number 0DJU which is a sycamore located on High Green outside a property known as Sycamore Cottage has significant issues which place the tree in a declining category with some degree of remedial action required. In the survey schedule two options are suggested, one is to dismantle the tree to ground level and grind out the stump (option 2 in the schedule) this would remove the issues surrounding the tree and allow for a potential replacement planting in an area close by. The second option (option 1 in the schedule) is to significantly reduce or pollard the tree to remove the weight and mechanical stresses placed on the trees' structural weaknesses by a full canopy, this option may allow the tree to be retained for a longer period but only if the trees' response to a heavy reduction was favourable and regrowth was to occur. This option also results in a significant reduction in the amenity of the tree until regrowth occurs and there is no guarantee of success in which case it would be likely that the tree would be removed anyway. It should be noted that this is only being suggested as an option should the value and significance of the tree and its obvious links to the adjacent property on a local level be deemed important enough to attempt this.

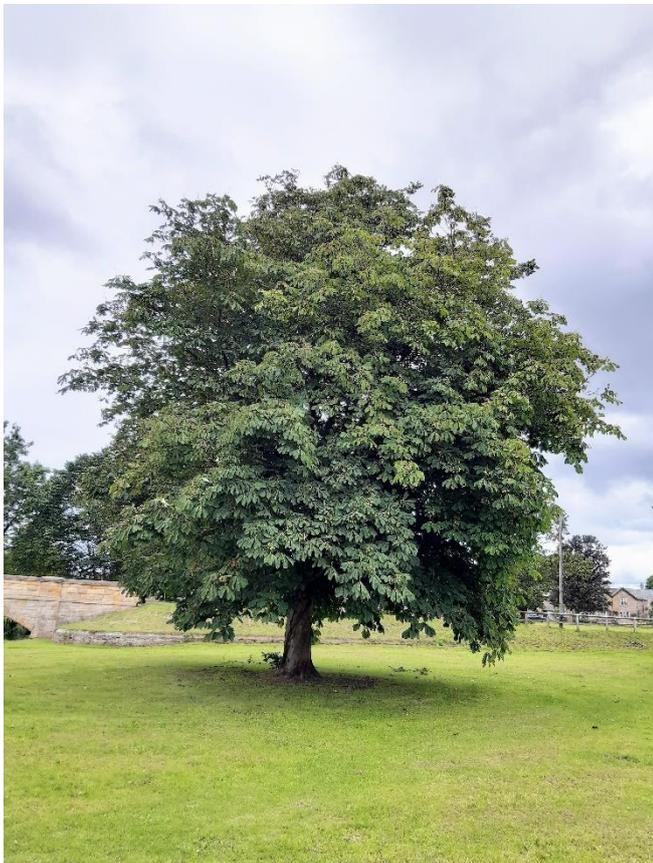
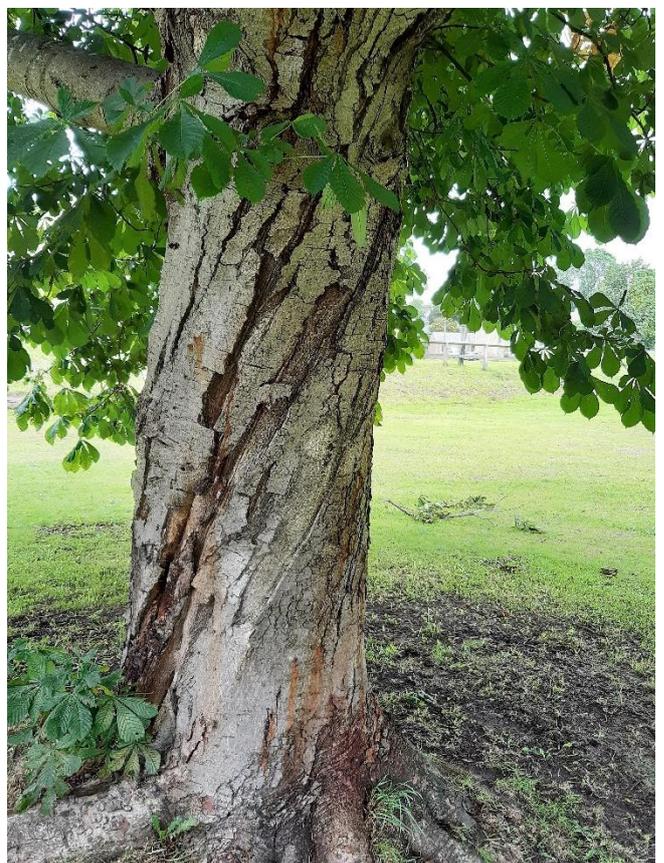
0DK5	Horse Chestnut	Mature	Reasonable	30-60cms	10-15m	Located between Greencroft and beck. Extensively affected by bleeding canker with previous limb loss evident currently the canopy is in good condition with high foliage density and vigour.	No works required, condition requires monitoring.	n/a
0DK6	Norway Maple	Mature	Good	30-60cms	10-15m	Located between rear of Chestnut House and beck, ivy growing on stem.	Sever ivy	Low
0DK7	Horse Chestnut	Mature	Reasonable	60-90cms	10-15m	Located to the rear of Roslyn House along green path to footbridge. Severely affected by bleeding canker with evidence of previous limb loss. Canopy is currently in good condition with high foliage density and vigour. Narrow stem union with included bark.	No works required, condition requires monitoring.	n/a
0DK8	Common Ash	Semi-Mature	Good	30-60cms	10-15m	Located next to bridge to the rear of Clow Cottage. Single low branch extends over beck-side path.	Lateral reduction of low branch by 4m	Low

Tree number 0DK5 (Horse Chestnut) showing healthy canopy but badly effected stem due to bleeding canker

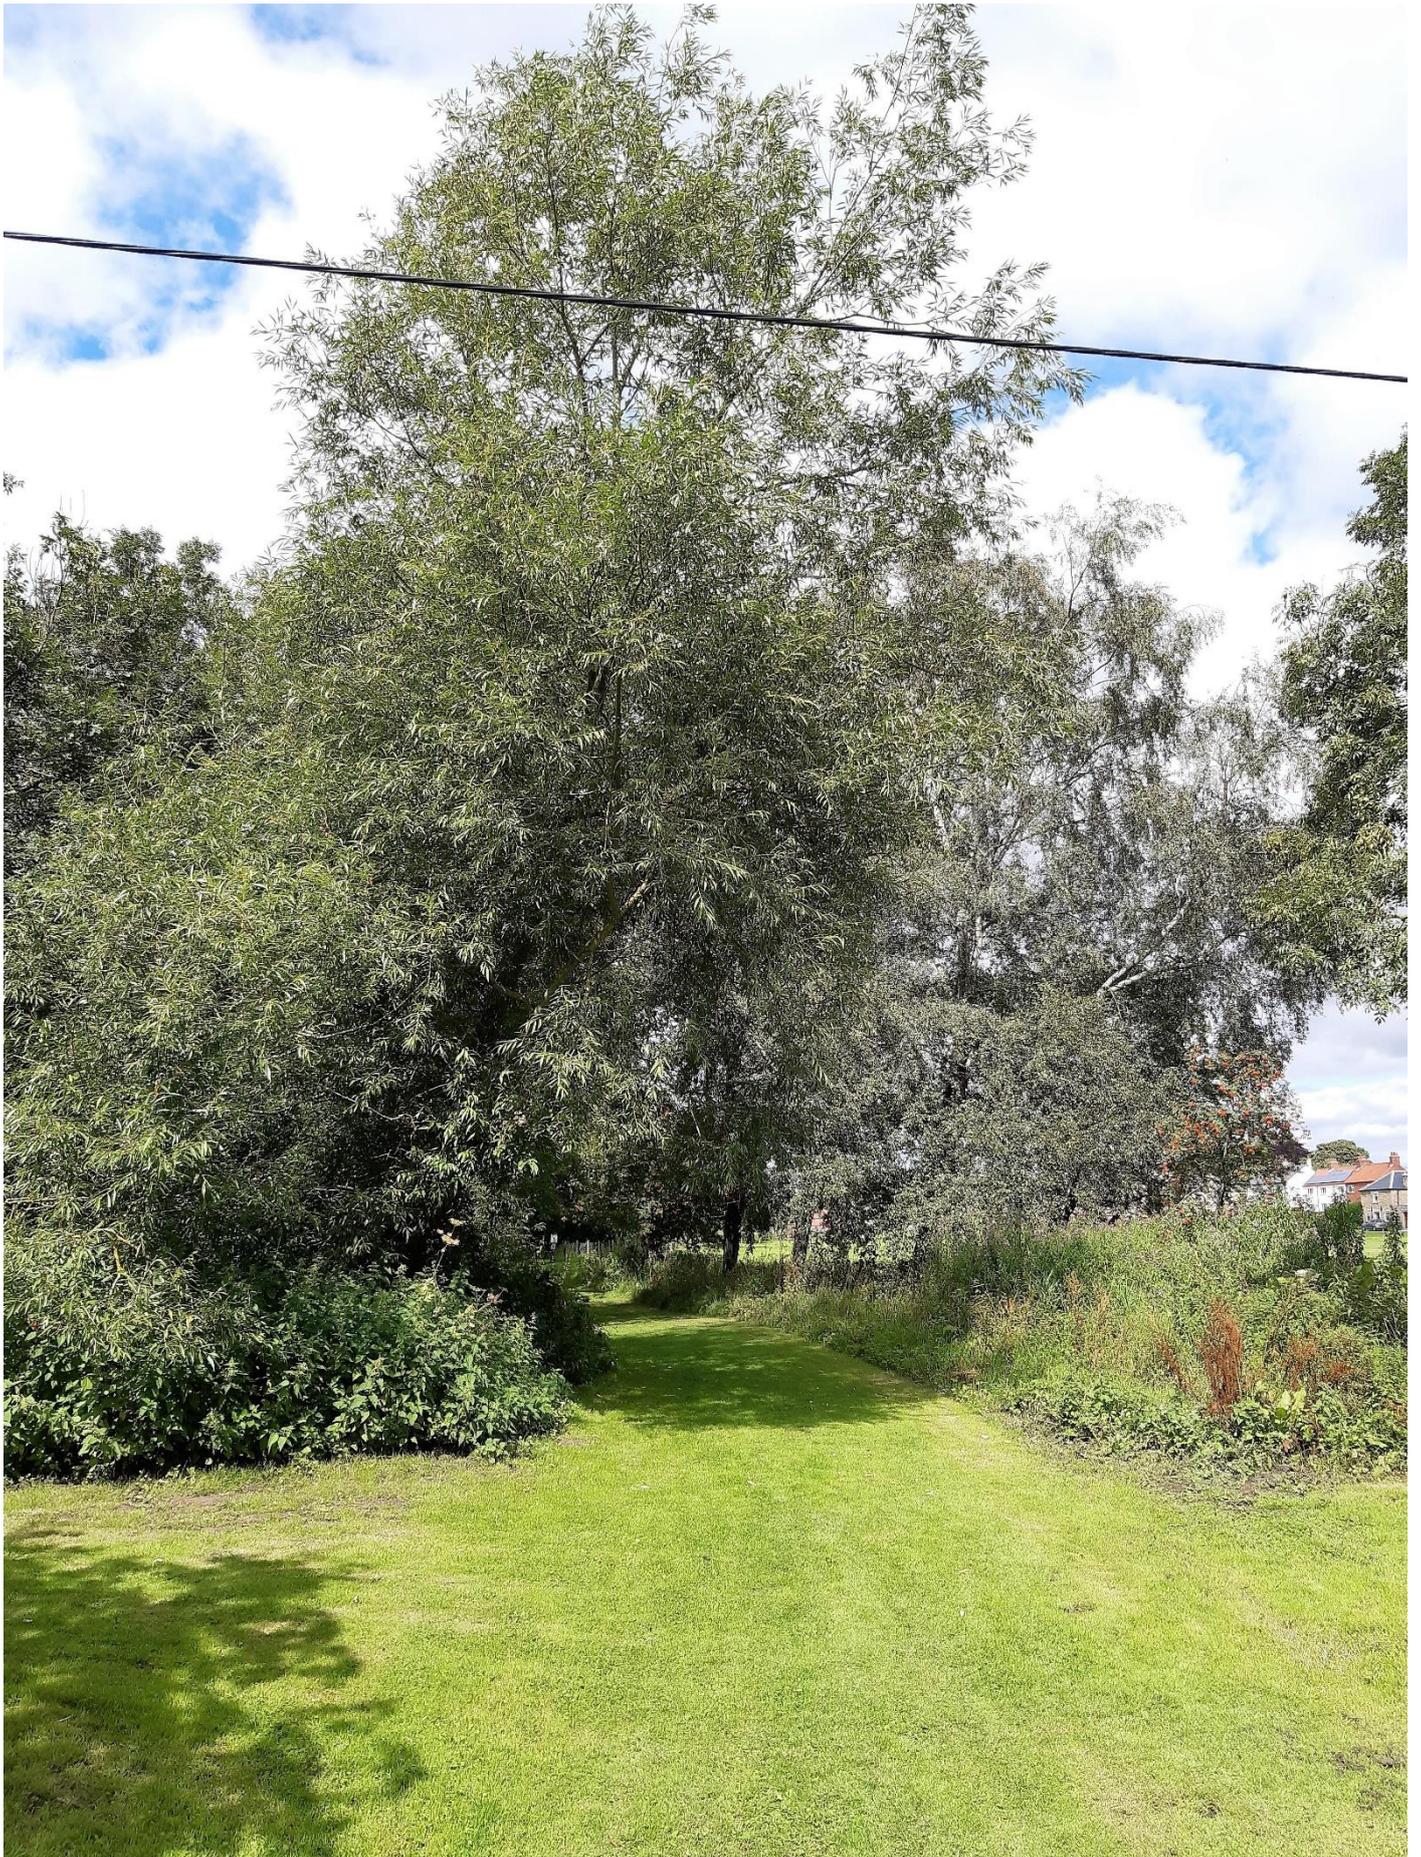
Group number 0DMB (Willow) showing extent of encroachment of mown path

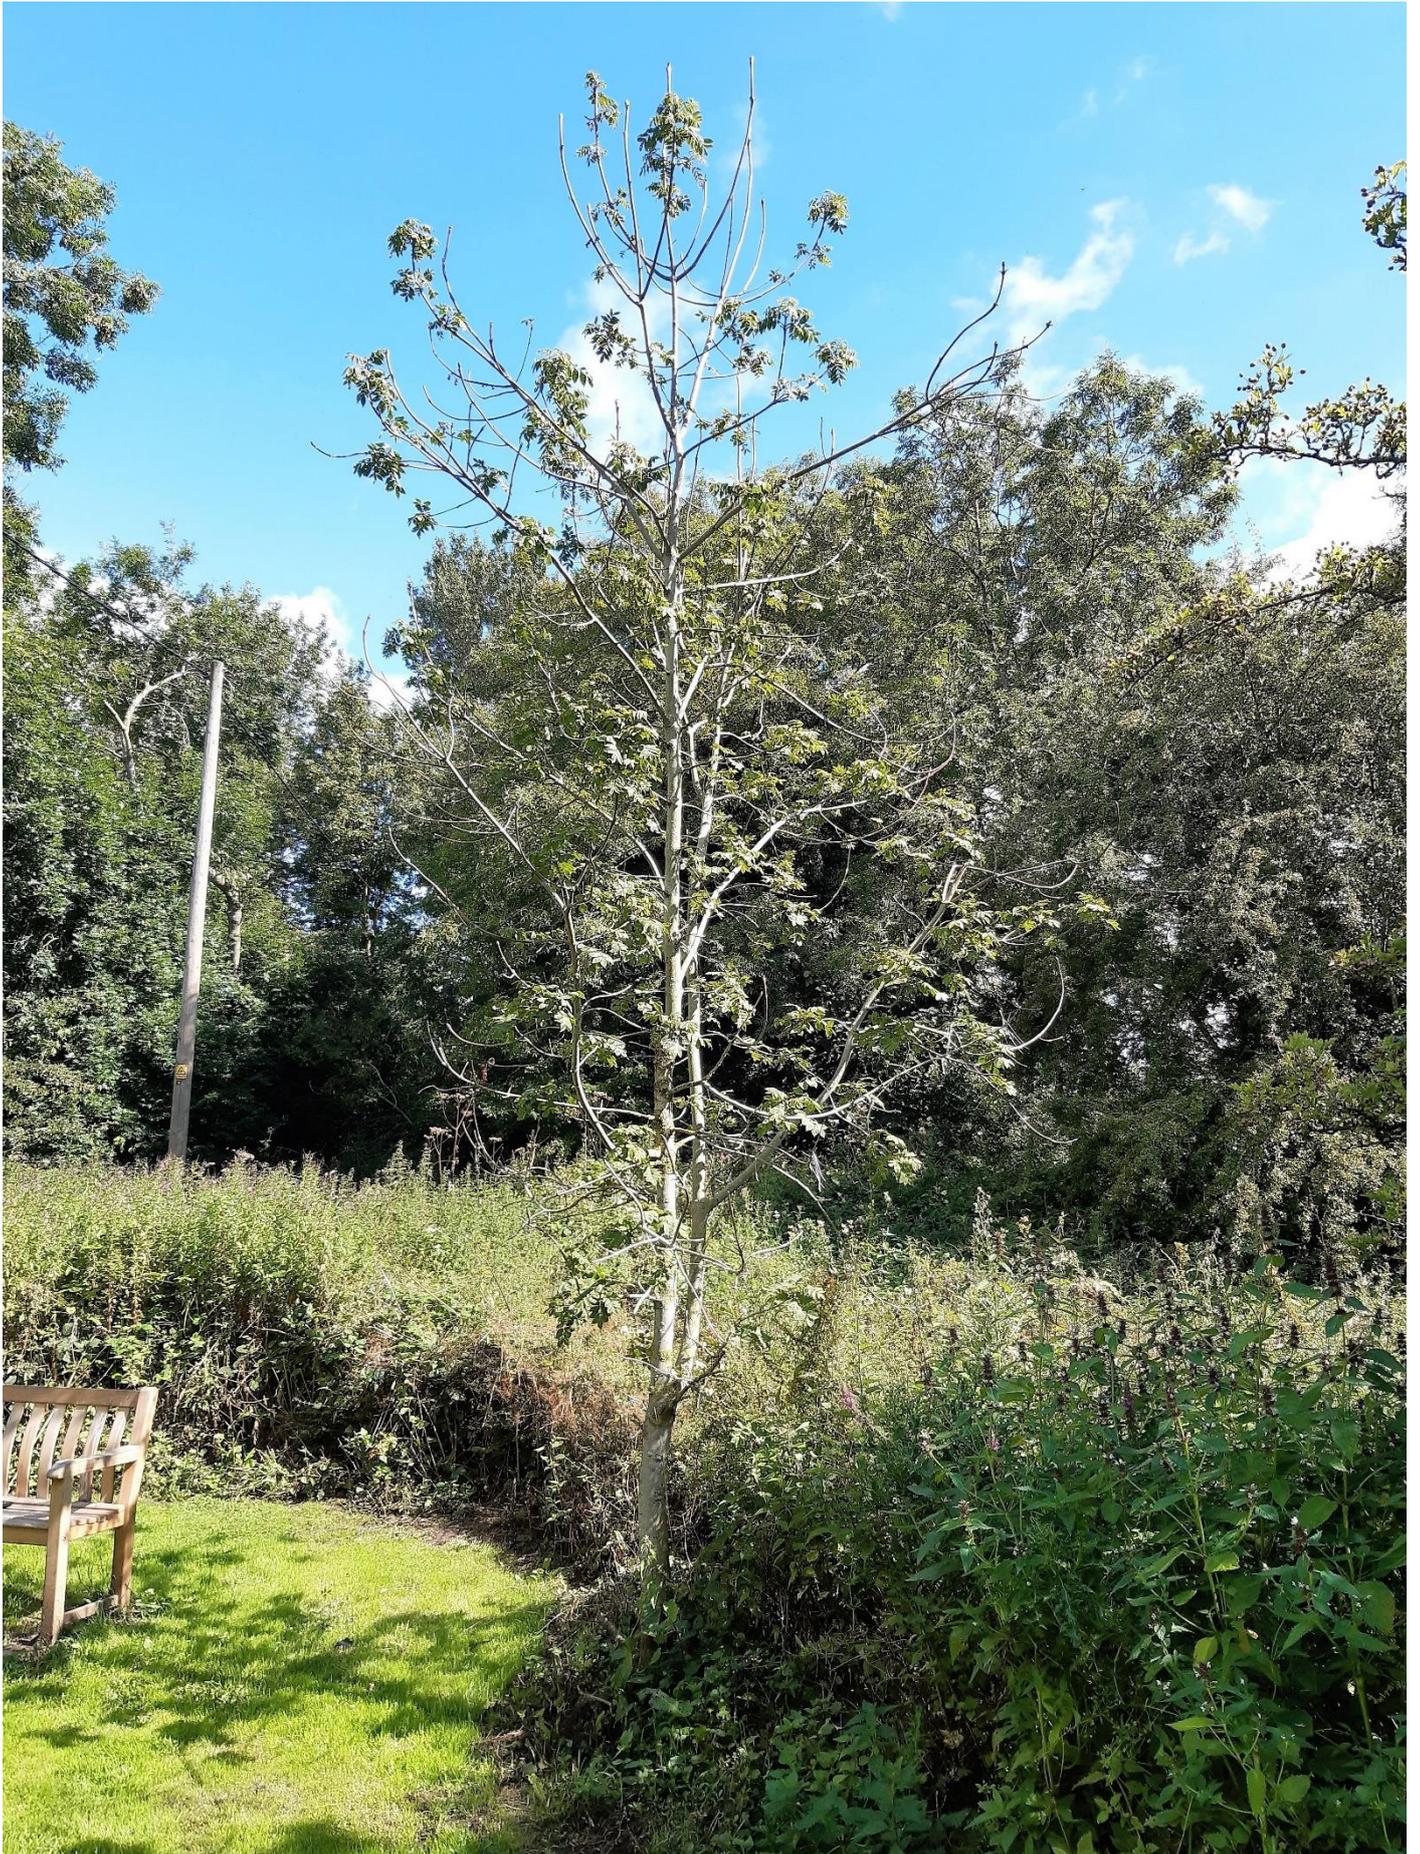
Tree number ODM6 (Common Ash) showing the rapid decline and ultimate death caused by Chalara ash dieback

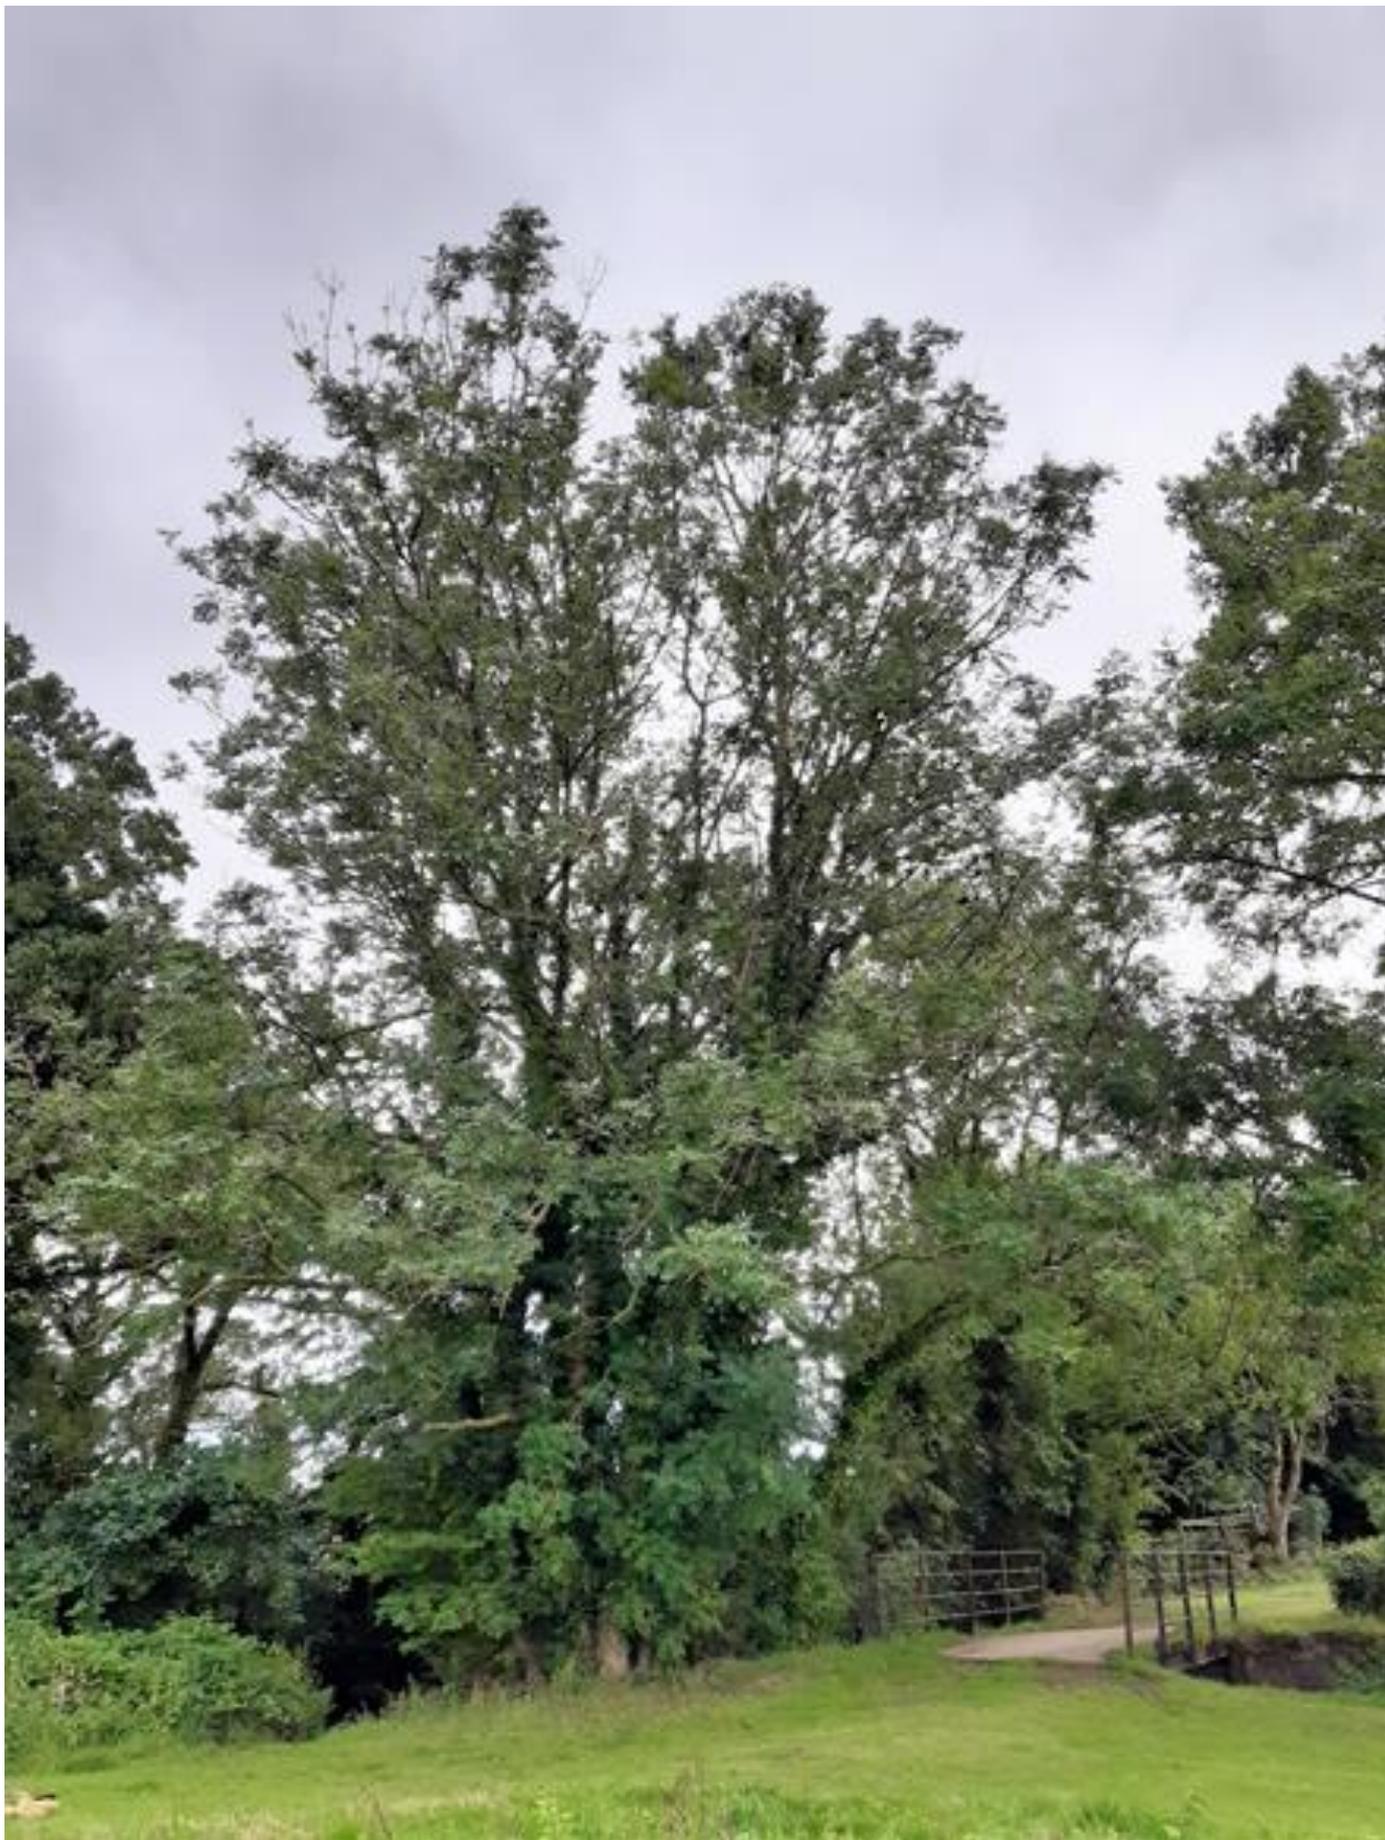
0DLN	Common Ash	Semi-Mature	Good	30-60cms	10-15m	Twin-stemmed tree with significant lean, low branches and asymmetric canopy.	No work required	n/a
0DLP	Common Ash	Mature	Reasonable	30-60cms	15-20m	Large multi-stemmed tree located next to footbridge to the rear of Clow Cottage. Ivy growth on stems, insignificant deadwood early stages of Chalara ash dieback infection evident.	Sever ivy at base.	Medium
0DLQ	Silver Birch	Mature	Good	30-60cms	15-20m	Low branches.	No work required	n/a
0DLR	River Birch	Semi-Mature	Good	15-30cms	10-15m	No significant defects evident.	No work required	n/a
0DLS	Silver Birch	Mature	Good	15-30cms	15-20m	No significant defects evident.	No work required	n/a
0DLT	Rowan	Semi-Mature	Good	7.5-15cms	0-5m	Multi-stemmed tree with no significant defects.	No work required	n/a
0DLU	Hawthorn	Mature	Good	30-60cms	0-5m	Multi-stemmed tree with no significant defects.	No work required	n/a
0DLV	Rowan	Young	Good	0-7.5cms	0-5m		No work required	n/a

Tree number ODLP (Common Ash) showing early stages of distal dieback caused by Chalara ash dieback
